# Culvert 34 Whitchurch Canal Breach Site

*Culvert Cleaning & CCTV Survey | Kier NR&N*

**LA-022-003 Culvert 34**

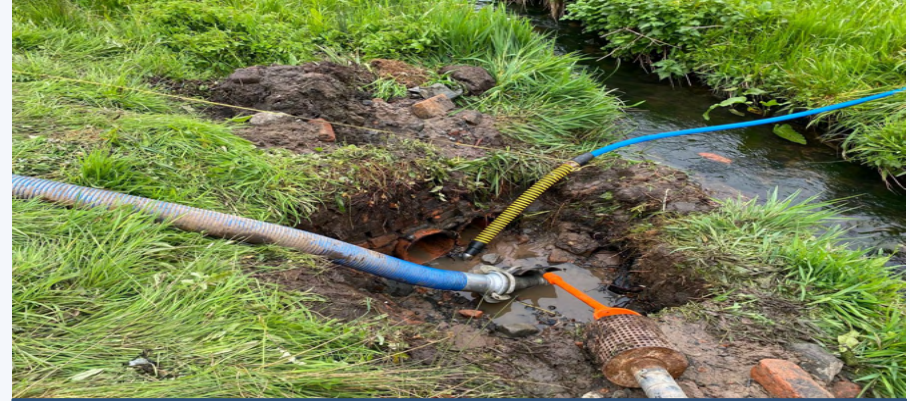
*De-watering setup at culvert outlet with twin pipe connection*

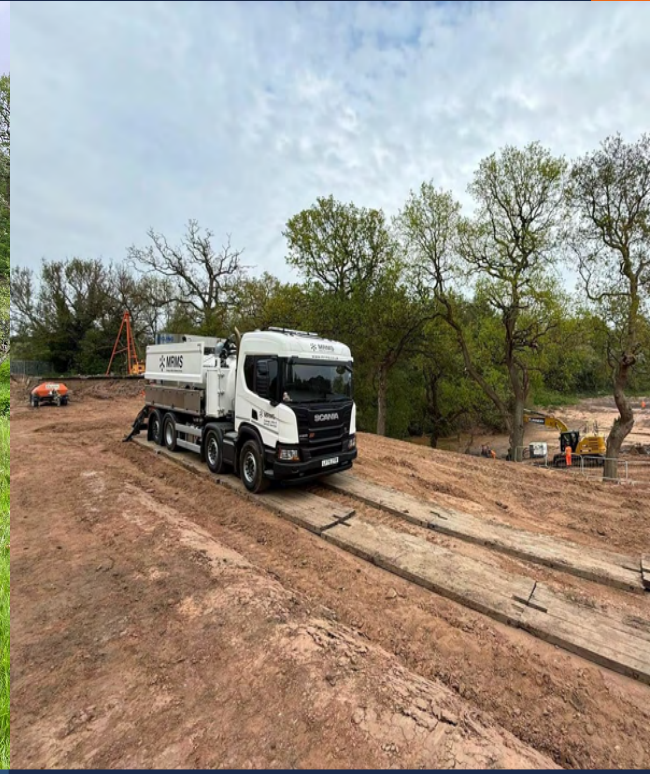
All pipes 100% full of debris due to the breach - finished silt levels reduced to less than 10%

*Exposed brick culvert arch at inlet - pre-clean*
